Nervous teenager prefers direct restoration

James Pegg describes the replacement of a failed amalgam restoration using minimal intervention techniques

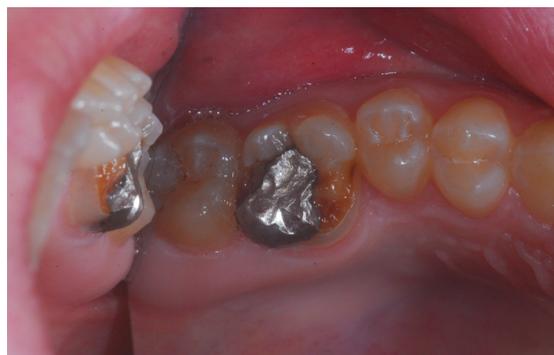
Figure 1: Examination revealed that a large amalgam restoration in the upper left first molar had fractured

A 15-year-old girl presented for an initial consultation, complaining that a filling in her back tooth had broken. She was not experiencing any pain, although she was finding the tooth rough and uncomfortable against her tongue. Examination revealed that a large amalgam restoration in the upper left first molar had fractured (Figure 1).

My recommendation to the patient was that the remainder of the failed filling should be removed. Once the quality of the underlying tooth structure had been assessed, a decision on how to restore the tooth could be made. The patient and her guardian agreed to this proposal.

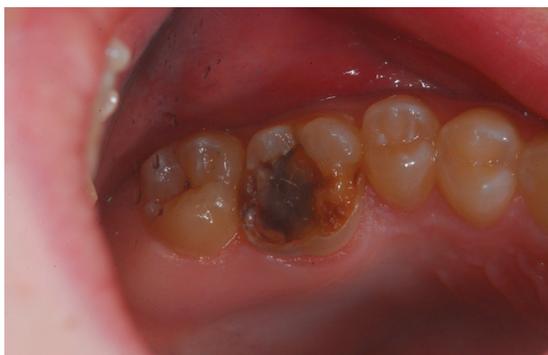
Figure 2: At the margins of the cavity there was a continuous 'rim' of supragingival enamel

At the treatment session, the remainder of the failed amalgam was removed under local anaesthesia. The underlying tooth structure was explored using Examvision 3.5x magnifying loupes. It was noted that at the margins of the cavity there was a continuous 'rim' of supragingival enamel. Some of this was stained, but none appeared carious. The dentine was similarly stained but no soft or carious tissue was seen (Figure 2). This was determined by gentle exploration, drawing the tip of a sharp probe across the surface.

Rubber dam was applied to isolate the tooth. The enamel margins at 26 were minimally prepared with an NSK air scaler with a diamond tip. The enamel and dentine surfaces were cleaned with an NSK Flash pearl powder/water slurry using an NSK Prophy-Mate neo air polisher.

A Triodent matrix system was applied to the tooth mesially and distally. After etching the enamel for 60 seconds and the dentine for 20 seconds, Ibond Total Etch was coated on to the tooth with a microbrush and light-cured.

Successive increments of Venus Pearl were added to the tooth, using the compule delivery system. Each increment was sculpted into place and light-cured.

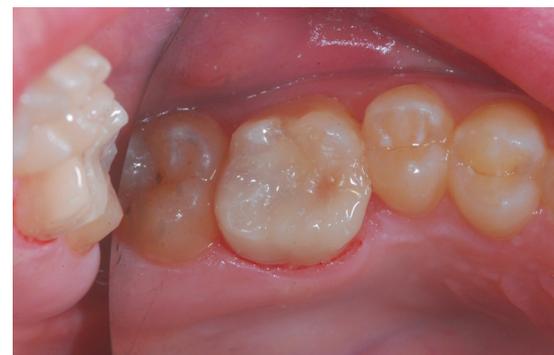
Figure 3: The patient was highly satisfied with the tooth-coloured restoration

Cases like this, with heavy amalgam staining, tend to be quite difficult to mask out. Venus Pearl performs this task exceptionally well. If I were to be self-critical of this case, I could have chosen a slightly darker dentine shade to perfectly match the surrounding tooth colour. However, the patient was highly satisfied with the end result and having a tooth-coloured restoration (Figure 3). She was not only pleased with the aesthetics but also with the minimally invasive process. **D**
